# FLOOD PLAIN MANAGEMENT STUDY

KASHWITNA RIVER, WASILLA,  
COTTONWOOD, AND LUCILE CREEKS  
ALASKA RIVERS COOPERATIVE STUDY

Susitna River Basin, Talkeetna Subbasin  
Matanuska-Susitna Borough, Alaska

May, 1982

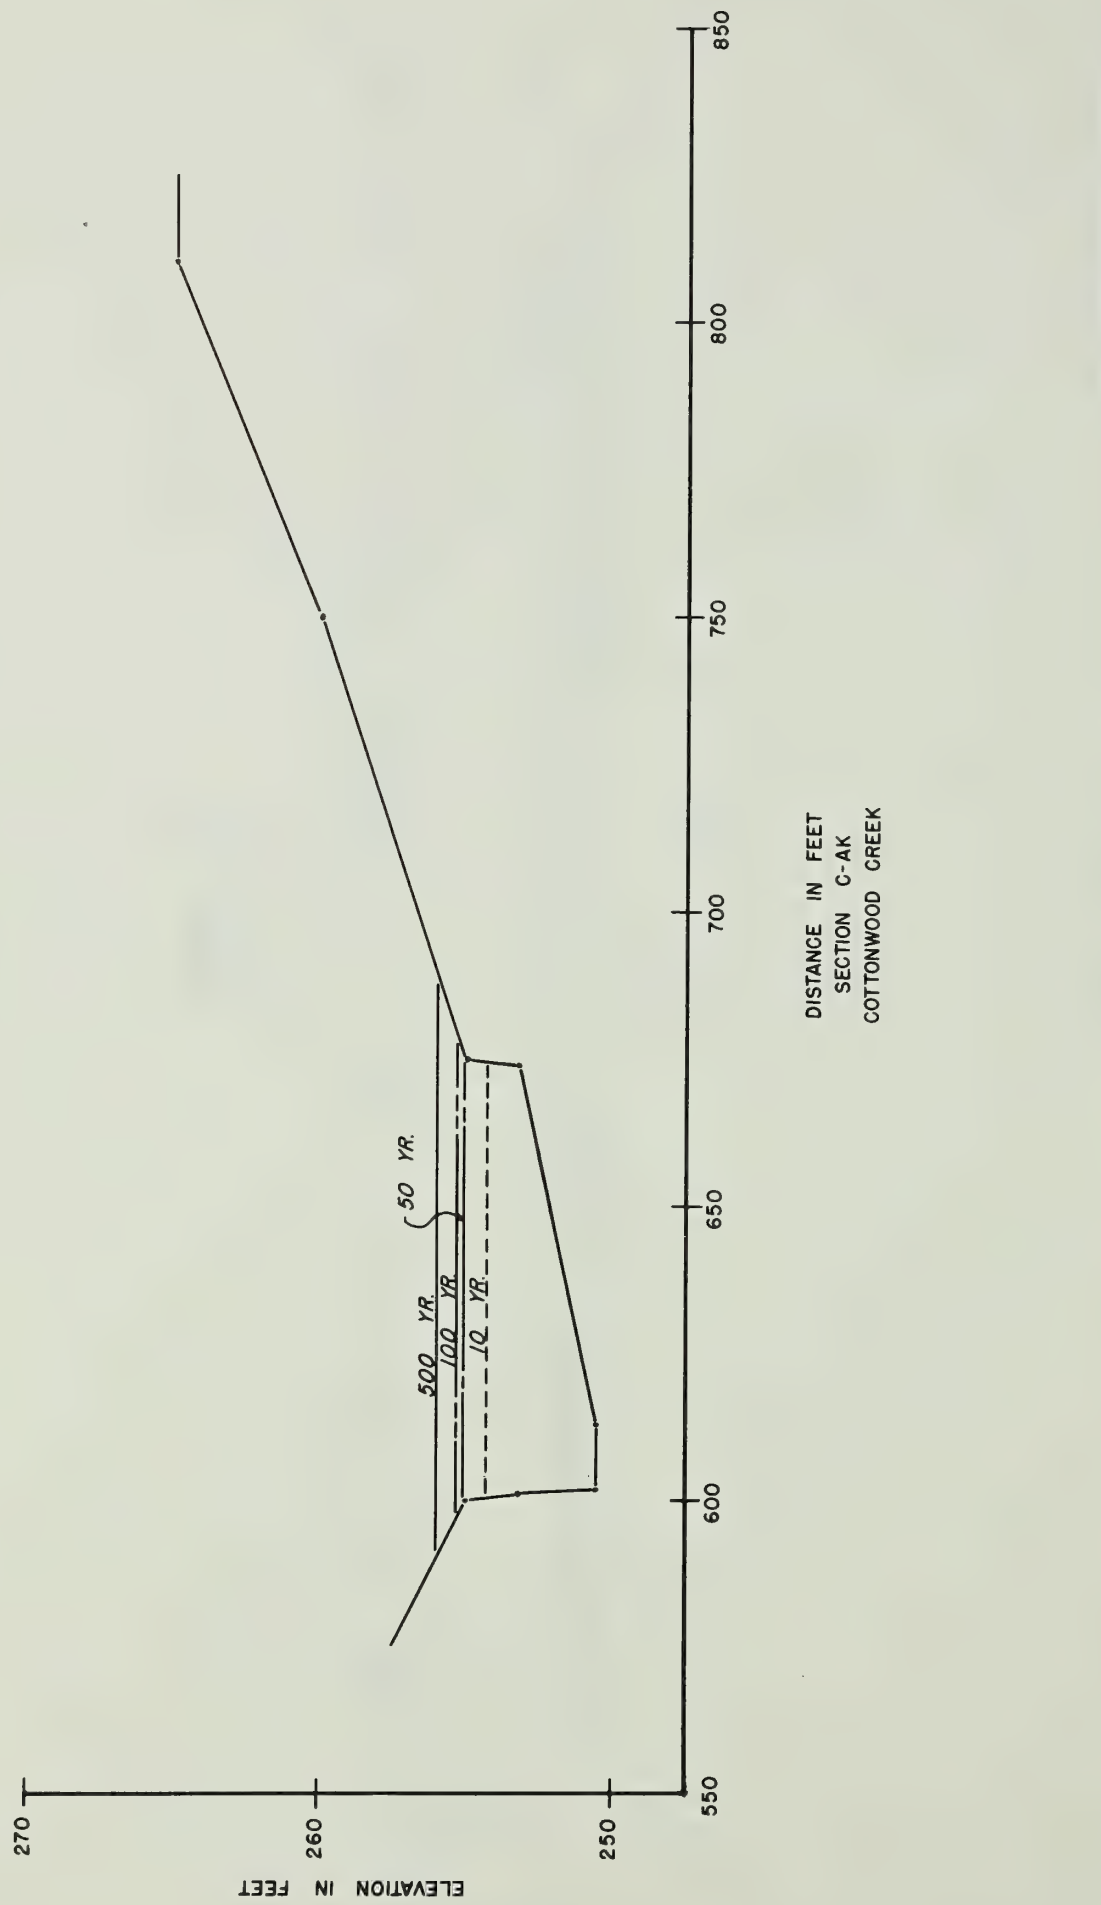
DISTANCE IN FEET  
SECTION C-AK  
COTTONWOOD CREEK

# TYPICAL VALLEY SECTION PRESENT CONDITIONS

Figures 2 through 174 are drawings of selected valley cross sections showing the flood elevations under present land use conditions for the 10-, 50-, 100-, and 500-year flood events.

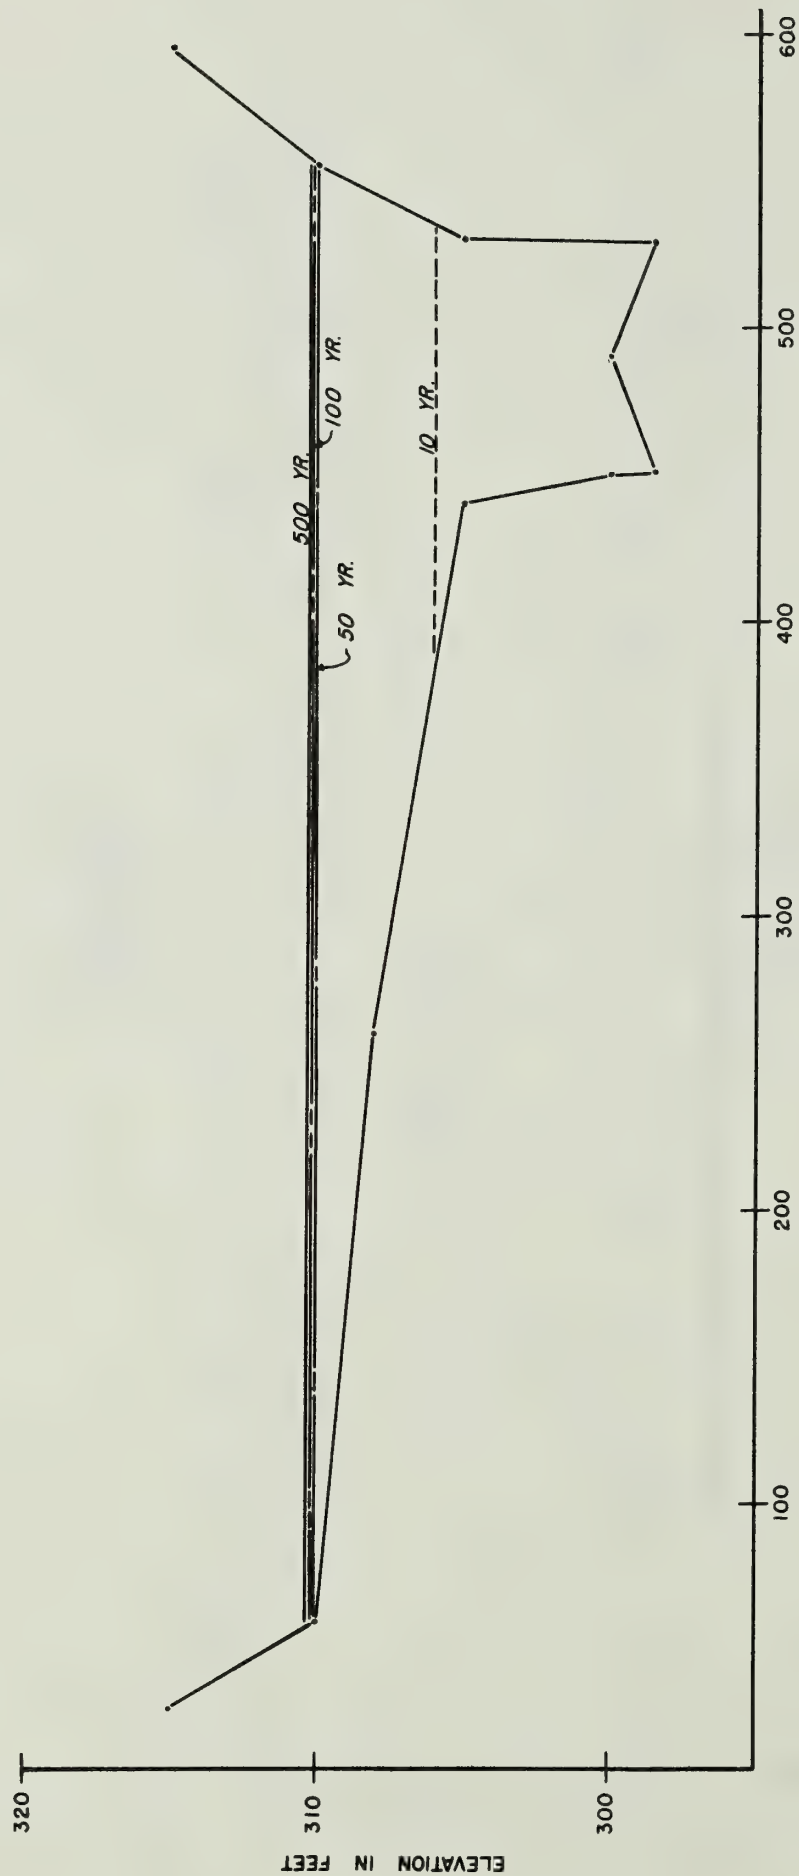
DISTANCE IN FEET  
SECTION C-AX  
COTTONWOOD CREEK

# TYPICAL VALLEY SECTION PRESENT CONDITIONS

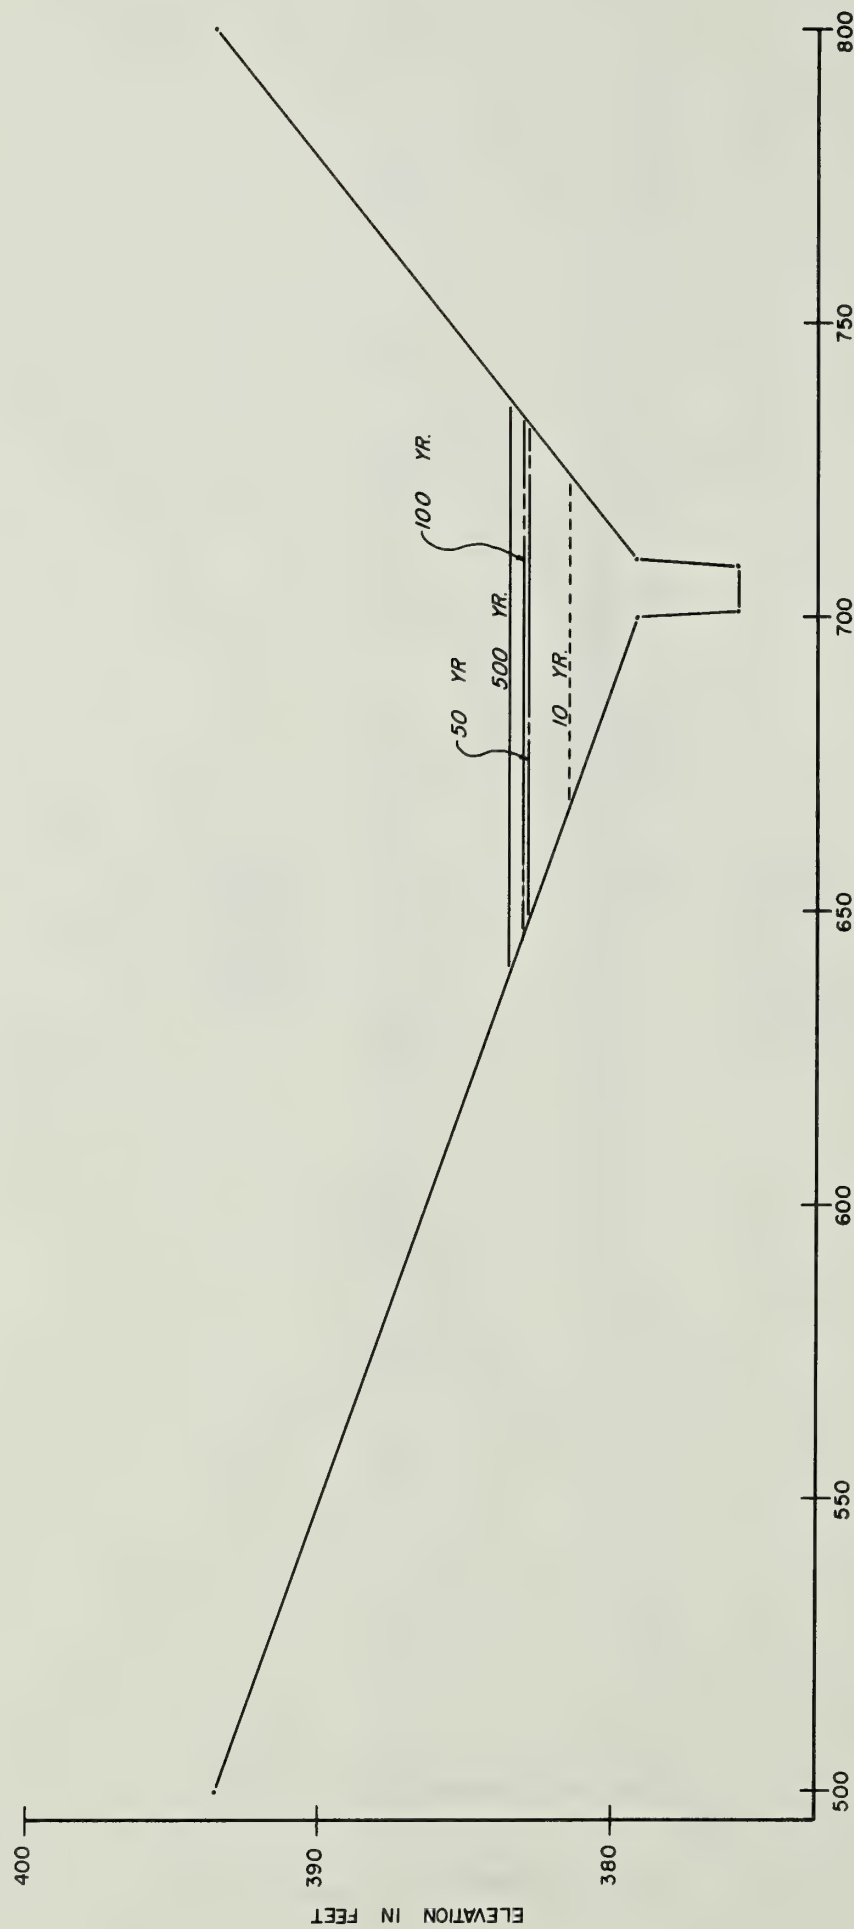
DISTANCE IN FEET  
SECTION C-BY  
COTTONWOOD CREEK

# TYPICAL VALLEY SECTION PRESENT CONDITIONS
